## **Inspector's Daily Report**

8								
IDR Sheet	1	of	=	1	Sheets	Final Record Book		Page
Contract					Day		Date	<i>♥</i>
C-7852					Monday			June 6, 2011

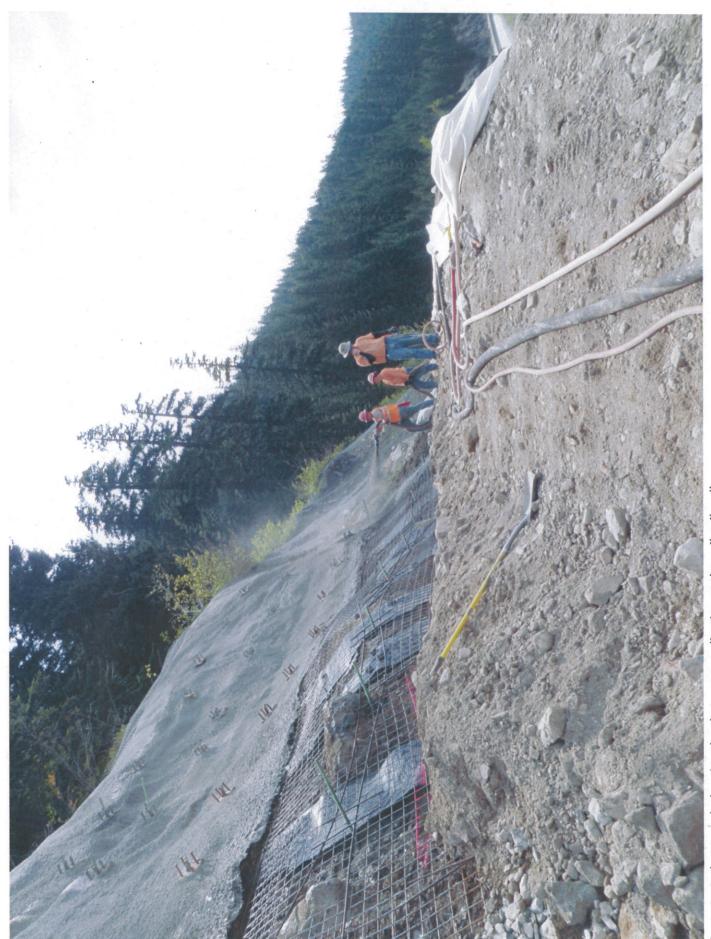
I arrived at the Hyak office around 9:00 am for the weekly conference call. Once the call was over I met with Brad Schut on the east end of the project while he was inspecting NW Cascade apply shotcrete on the soil nail wall (Figure 1). According to Brad, NW Cascade was able to apply the first 4 cubic yards of material; however, the remaining shotcrete was recalled due to too much air in the mixture.

Figure 1. A photograph showing the shotcrete application at the soil nail wall.

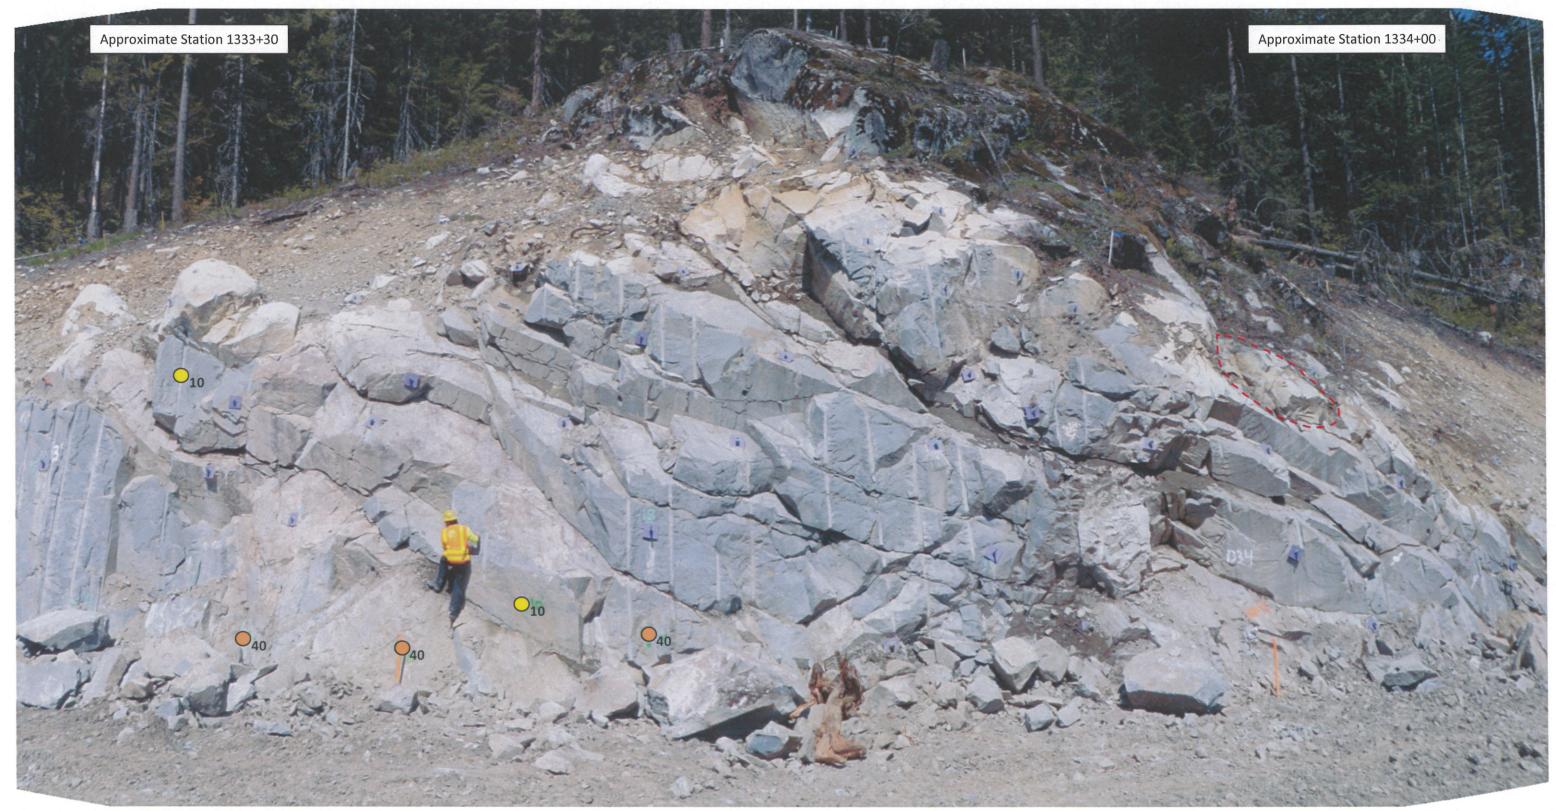
Brad and I walked over to Jenkin's Knob, around station 1330+30 to 1334+10 and located two 10 foot Type L spot dowels that are shown in Eric Smith's 6/3/2011 IDR and a mechanical scaling location (Figure 2). Brad and I also located three 40 foot Type H rock dowels in the same area that was detailed in a memorandum written by Norm Norrish, dated XXXXX (Figure 2).

Figure 2. A photograph showing the dowels located from approximate station 1333+30 to 1334+10. Note the scaling area around station 1334+10.

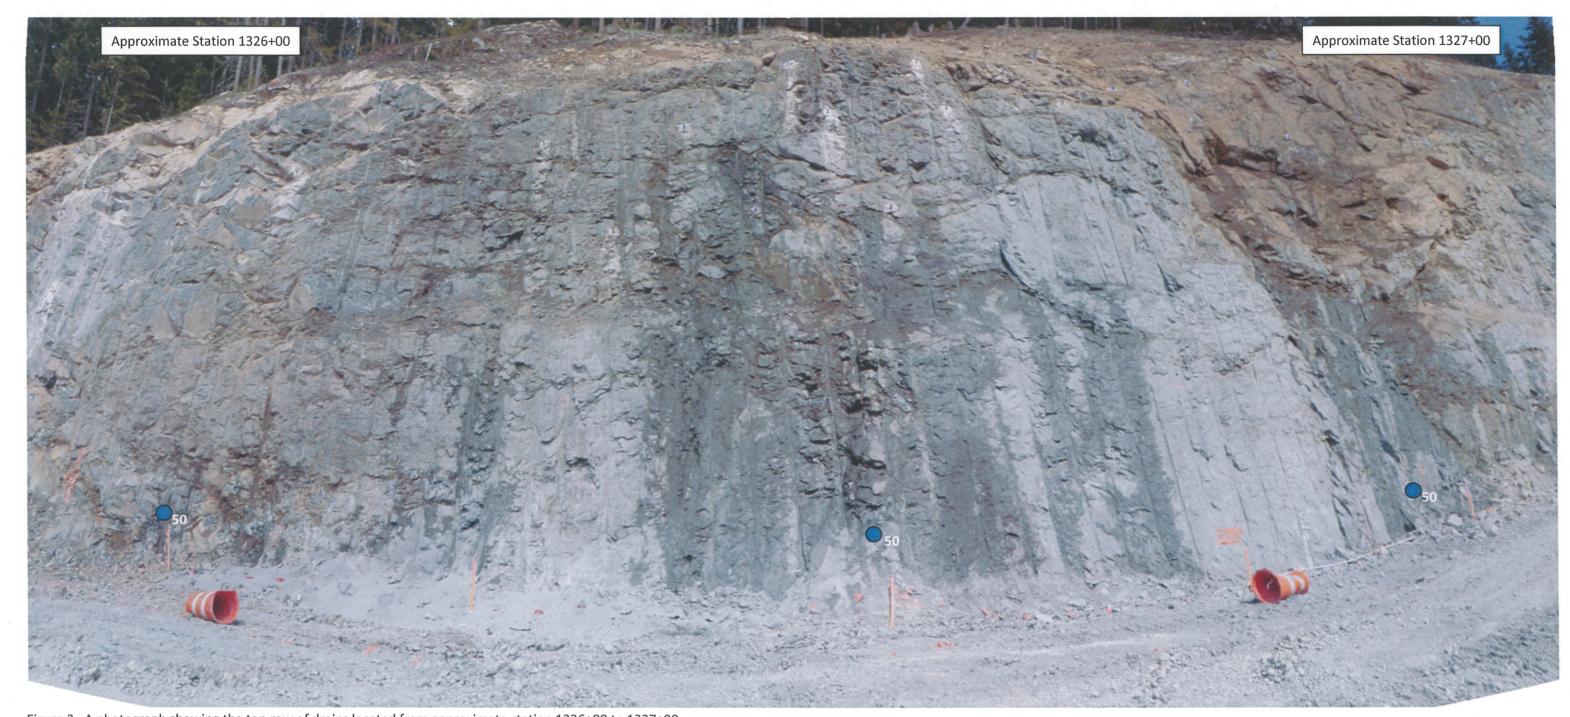
Brad and I located three 50 foot horizontal drains from approximate station 1326+00 to 1327+00 approximately 27 feet above the finished ditch bottom (Figure 3). Brad and I also located eight 25 foot Type L dowels in the "amber alert" area around station 1325+00 in the shotcrete area (Figure 4). These dowels should be drilled before shotcrete application.

Figure 3. A photograph showing the top row of drains located from approximate station 1326+00 to 1327+00.

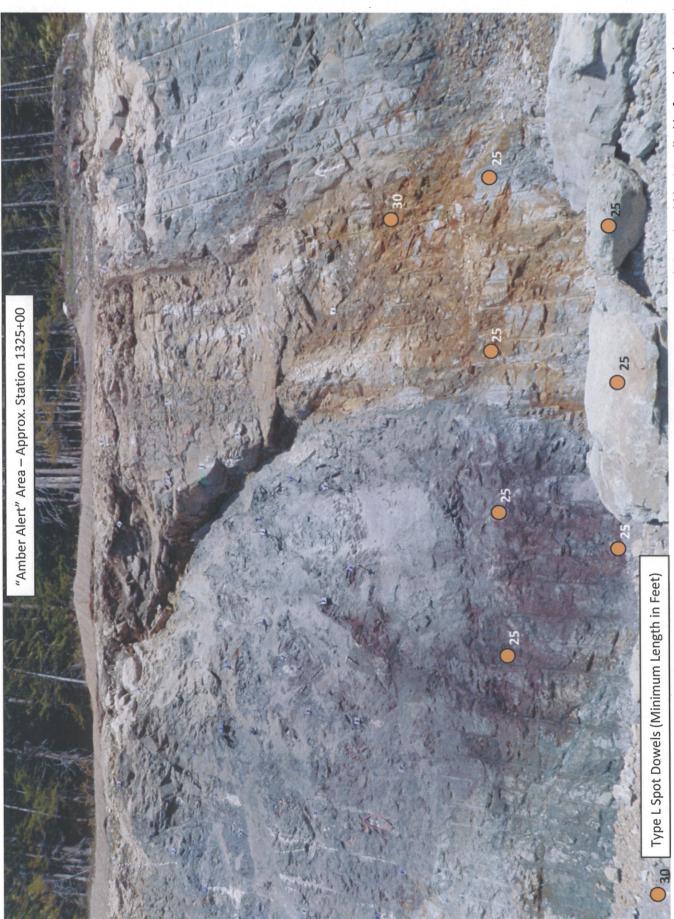
Figure 4. A photograph showing additional Type L pattern dowels in the "amber alert" area (station 1325+00) that should be installed before the shotcrete application. Note the approximate spacing is 12' on center. The bottom row should be placed about 12 feet below the next row above.

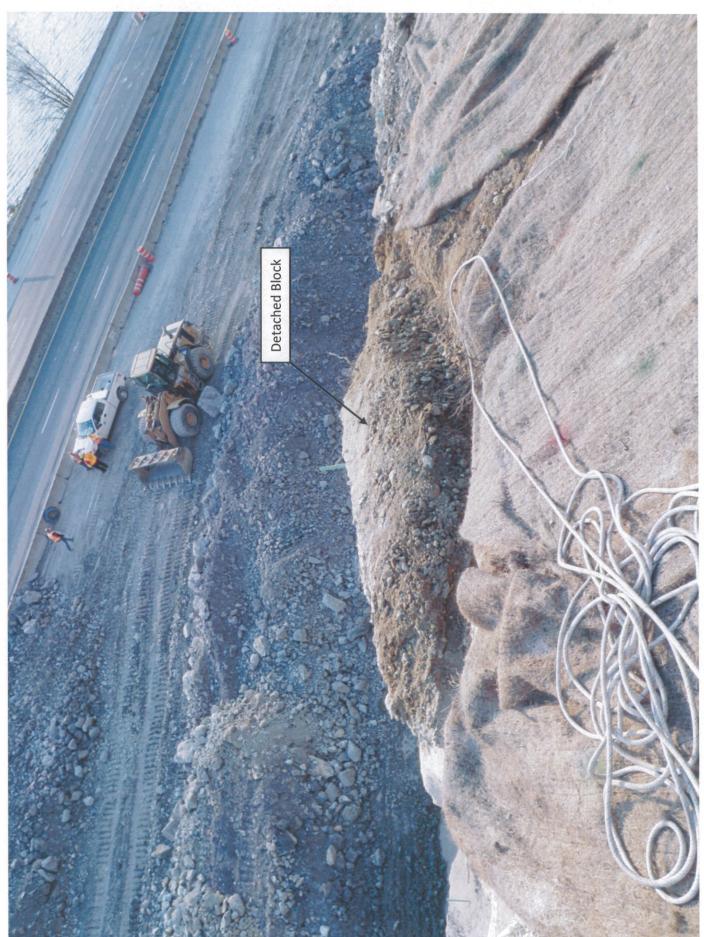
I met Brad on the west side of the project around 6:00 pm before the planned blast at 7:30 pm. Brad and I intended to remove the detached block that has developed at the crest of the slope in the "amber alert" area. We walked upslope and set up our ropes and waited until the highway was closed and the blast was cleared for work to begin. Once the "all clear" was sounded, Brad and I climbed down to the crest of the slope and began removing material with a scaling bar and a shovel. We were only able to remove the upper 2 to 3 inches and quickly learned that the majority of the detached block was cemented and we were not able to pick it apart (Figure 5). Brad and I attempted to pry the detached block loose and the block would not move. We determined that a scaling contractor would need to work on this area with air pillows or jacks to remove the detached block.

Figure 5. A photograph of the detached block located at the crest of the slope at the "amber alert" area, approximate station 1325+00.
